DEPARTMENT OF TRANSPORTATION**DIVISION OF ENGINEERING SERVICES**

Contract #: 04-0120F4Cty: SF/ALA Rte: 80 PM: 13.2/13.9File #: 1.28**WELDING INSPECTION REPORT****Resident Engineer:** Siegenthaler, Peter**Address:** 333 Burma Road**City:** Oakland, CA 94607**Report No:** WIR-016706**Date Inspected:** 10-Sep-2010**Project Name:** SAS Superstructure**OSM Arrival Time:** 700**Prime Contractor:** American Bridge/Fluor Enterprises, a JV**OSM Departure Time:** 1530**Contractor:** American Bridge/Fluor Enterprises, a JV**Location:** Jobsite**CWI Name:** See below**CWI Present:** Yes No**Inspected CWI report:** Yes No N/A**Rod Oven in Use:** Yes No N/A**Electrode to specification:** Yes No N/A**Weld Procedures Followed:** Yes No N/A**Qualified Welders:** Yes No N/A**Verified Joint Fit-up:** Yes No N/A**Approved Drawings:** Yes No N/A**Approved WPS:** Yes No N/A**Delayed / Cancelled:** Yes No N/A**Bridge No:** 34-0006**Component:** SAS OBG**Summary of Items Observed:**

- 1). OBG Field Splice 2W/3W Weld ID: ALS4 & ALS5
- 2). OBG Field Welding of Lower Lug Restoration between PP12 - PP13 - (SMAW)
- 3). OBG Field Welding of Studs to Edge Plate Weld B1 adjacent to 5W/6W - (SMAW)
- 4). OBG Fiel

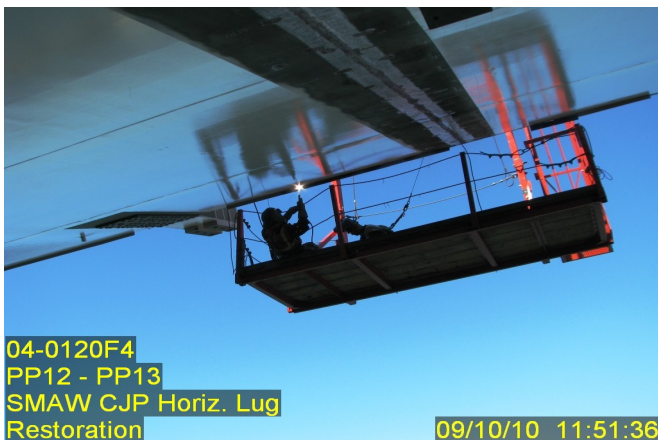
The QAI periodically observed AB/F approved welder Rick Clayborn (ID 2773) performing CJP welding per the Shielded Metal Arc Welding (SMAW) process in the 2G (horizontal) and 4G (overhead) positions to restore a portion of the counter weight assembly lower lug at the edge plate at W1. See photo below. QC Inspector Mike Johnson was periodically present to monitor the progress and verify that the welding parameters were within the limits established by the approved welding Procedure Specification (WPS) identified as ABF-WPS-D1.5-1000.

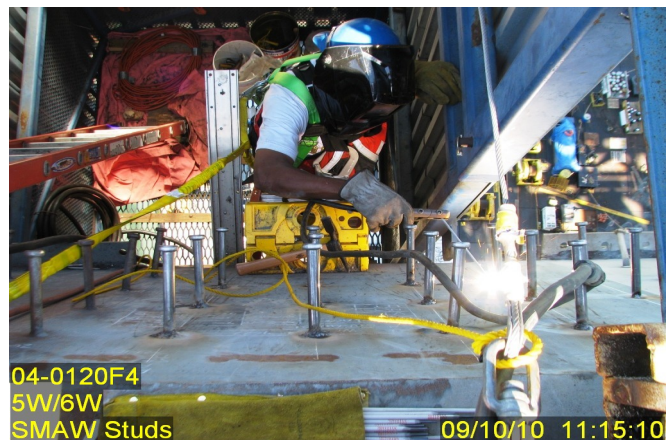
The QAI periodically observed AB/F approved welder Darcell Jackson (ID 9967) performing fillet welding per the Shielded Metal Arc Welding (SMAW) process in the 2F, 3F and 4F positions to repair and to attach Studs to the edge plate on the Counter Weight side of the OBG between. See photo below. QC Inspector Mike Johnson was periodically present to monitor the progress and verify that the welding parameters were within the limits established by the approved welding Procedure Specification (WPS) identified as ABF-WPS-D1.5-F1200A. The QAI observed that the work appeared to be in general compliance with contract documents.
